HELLSTROM HOME INSPECTION SERVICES, INC.

Home Inspection Report

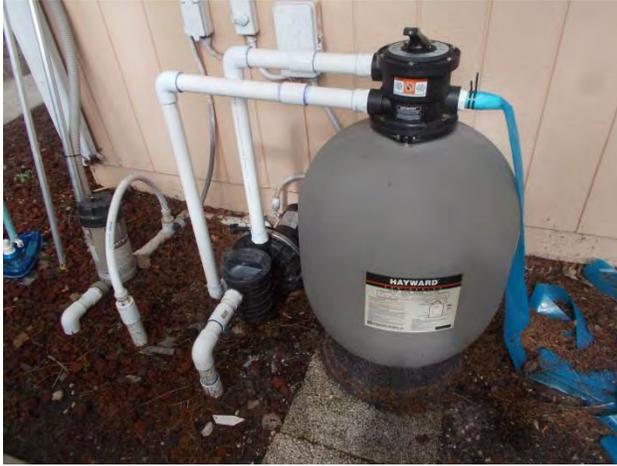
The pool is an older model, but appears to be in very good shape. The pool pump and sand filter both appear to be fairly new. The pool light is protected with a GFCI breaker at the main panel, but did not work (the seal is apparently damaged and allows water into the light that will trip the breaker). I'd recommend having a pool specialist fully assess the pool equipment and repair the pool light.

Pool equipment

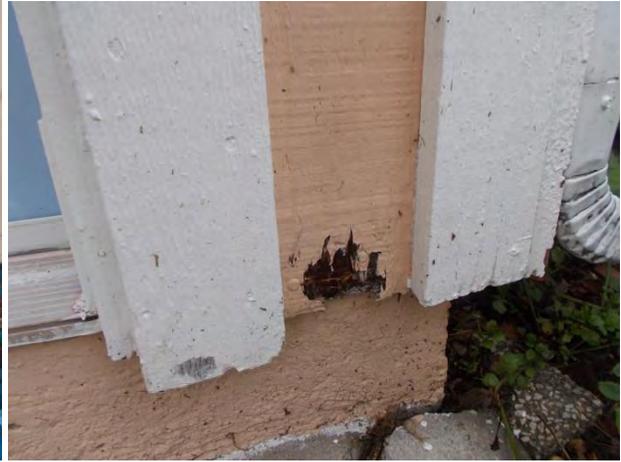
- Wood rot near exterior door

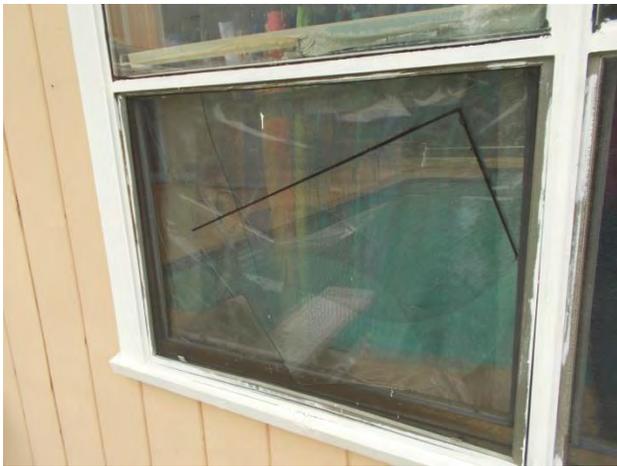
Broken window pane at pool house

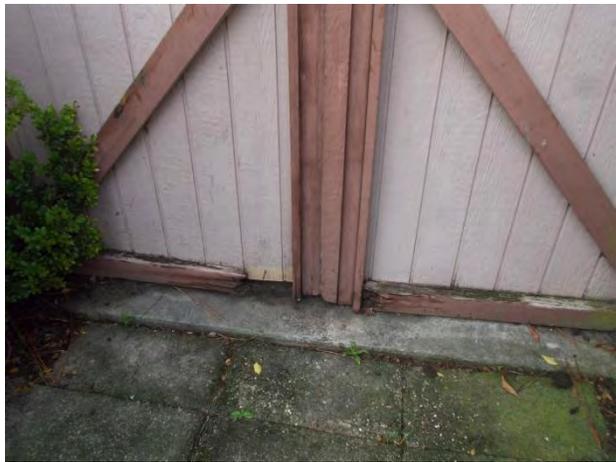
- Wood damage at shed

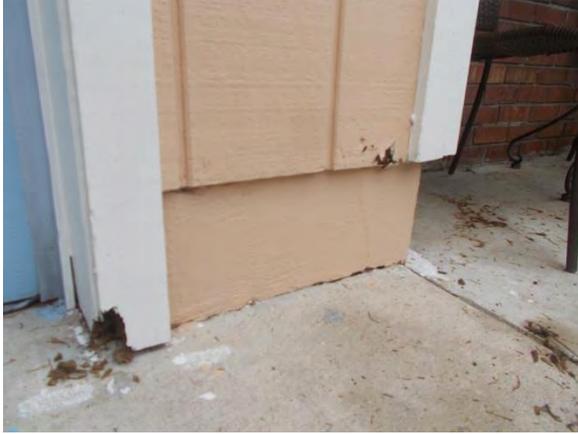
There is also wood rot at the wood trim at the garage door that should be replaced.

Wood rot by garage door

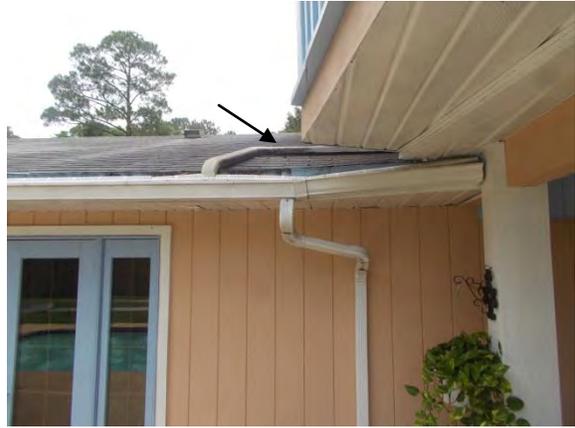
Leak area at rear eave

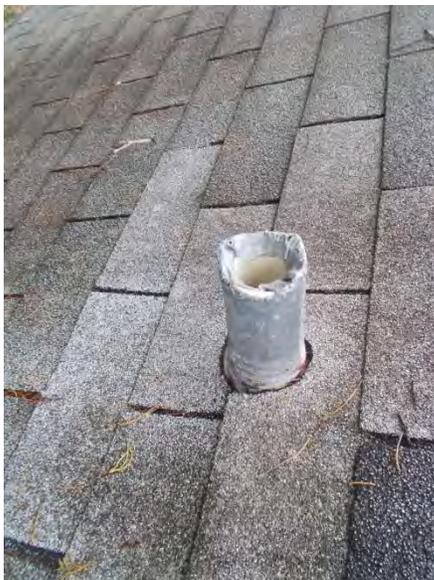
The lead flashing at one plumbing stack has been chewed/damaged by squirrels and needs to be sealed. When flashing boots are replaced, I'd recommend screening over the flashing at all plumbing stacks to prevent future damage. With the nearby trees, squirrels will always be able to access the roof.

Squirrel damaged plumbing stack flashing

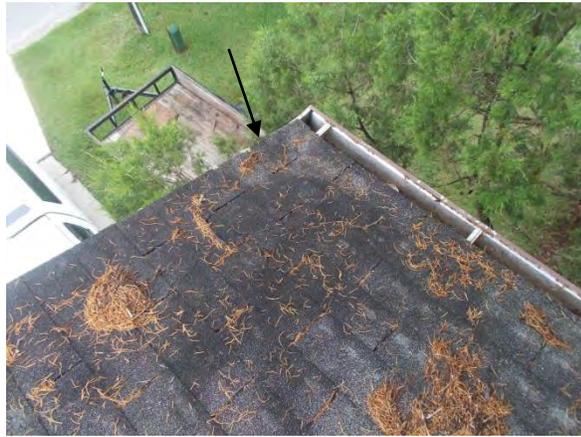
Homeowner's insurance companies require at least 5 years life for the shingles and the shingles have less than a year's life and there are several small leaks (front/north corner, upper roof, by balcony) that need repair.

- Leak at NW roof corner

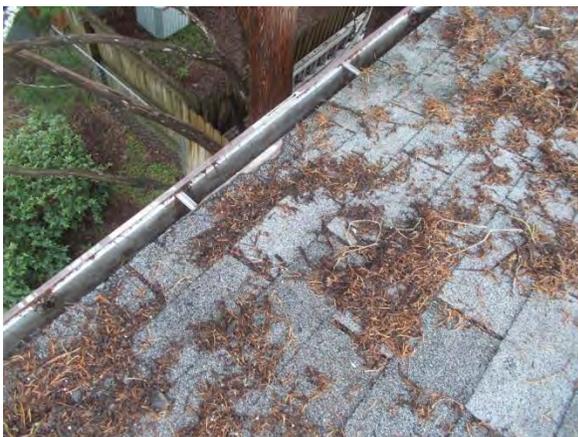
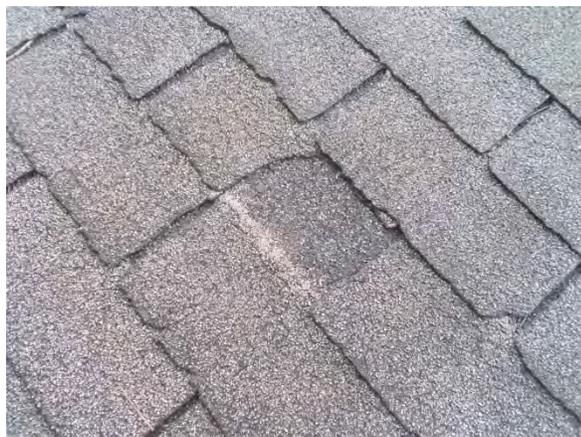
The main roof is covered with 3-tab composition fiberglass shingles. The shingles are probably 20 years old, are in poor shape, and should be assessed by a licensed roofer for replacement.

Examples of worn shingles

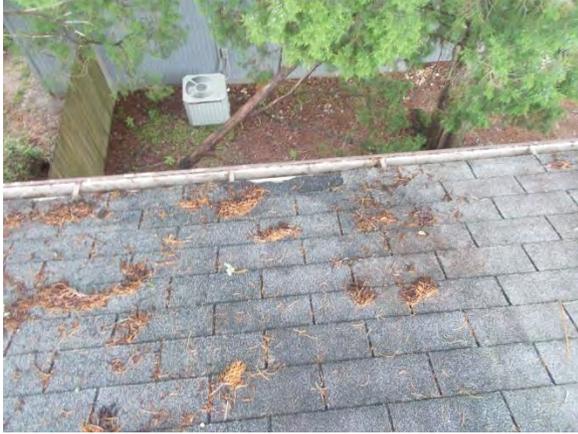
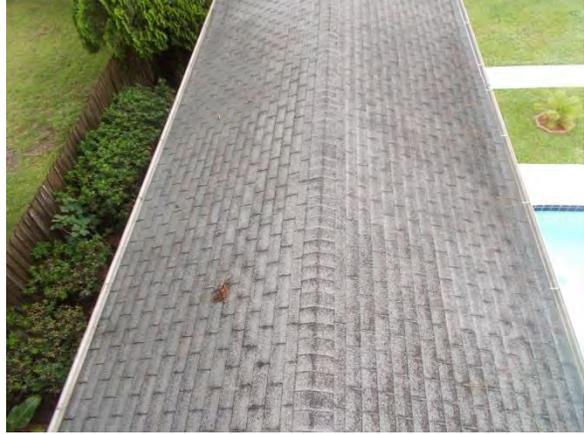
Examples of worn shingles

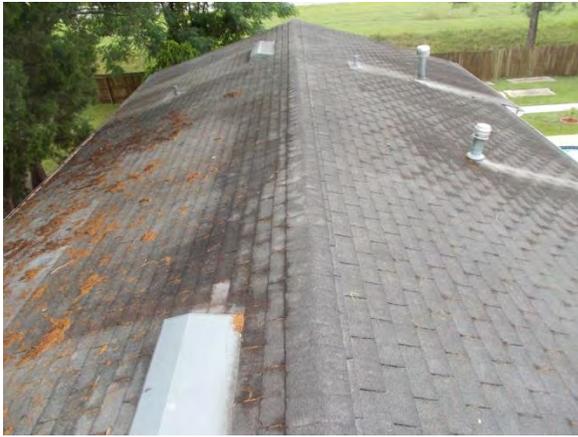
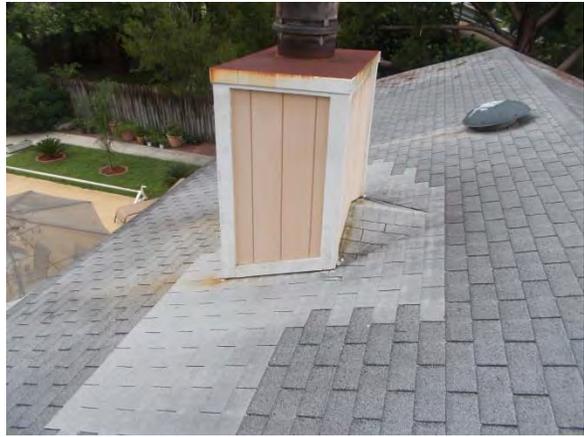
Examples of worn/stained shingles

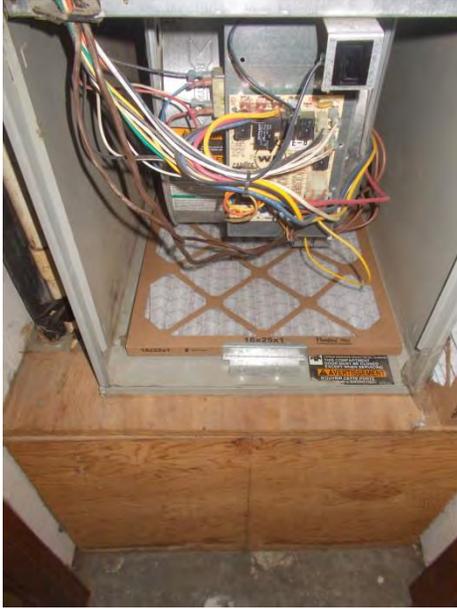
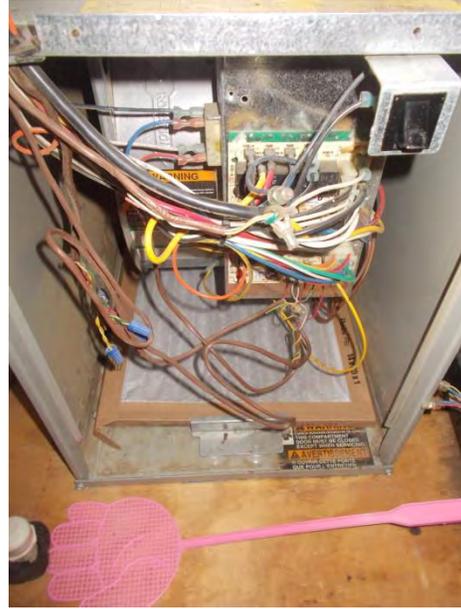
The AC filters are at the lower furnace panels. The 14" x 25" and 16" x 25" filters should be replaced every 1-2 months. Proper filter maintenance will help the AC perform better and cause less stress on the expensive equipment.

AC filters at lower furnace panels

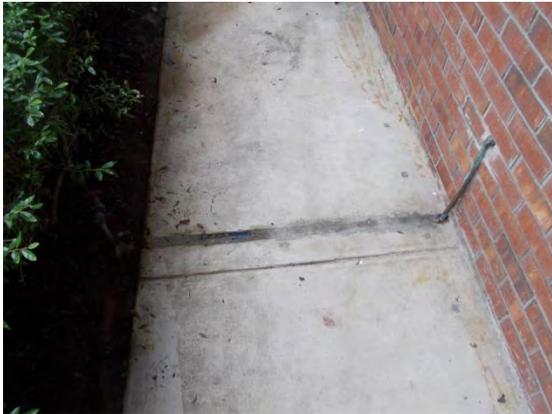
Need to cover and insulate pipe at front walkway

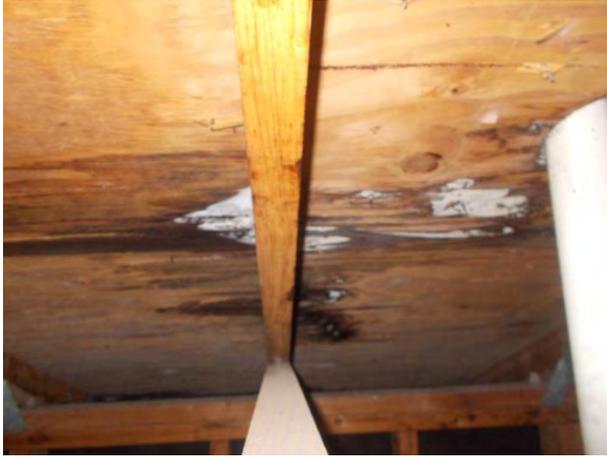
Leak at upper roof near scuttle roof

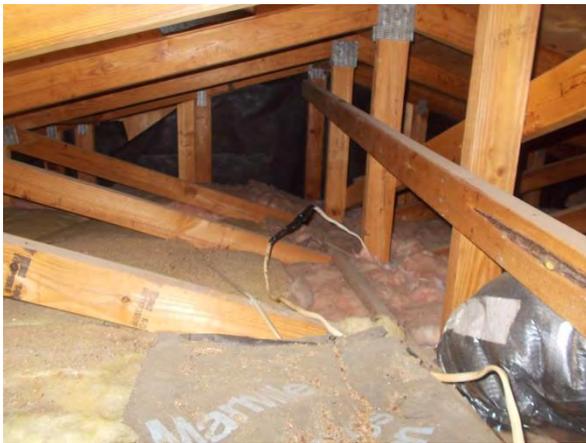
There are wiring splices at the west attic and at the upper attic that should be placed in closed junction boxes and should be nailed to trusses.

Wiring splice (west attic) needs to be boxed

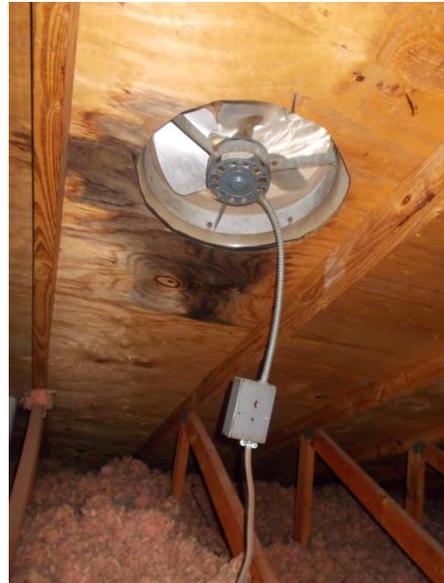
The upper roof/attic is adequately ventilated with soffit vents and two off-ridge roof vents. When shingles are replaced, better ventilation should be installed. The attic fan did not work and has a broken cover (duct-taped now). Proper ventilation will reduce hot attic temperatures, reduce stress on the AC equipment, save energy, and protect the roof shingles.

-Non-functional attic fan

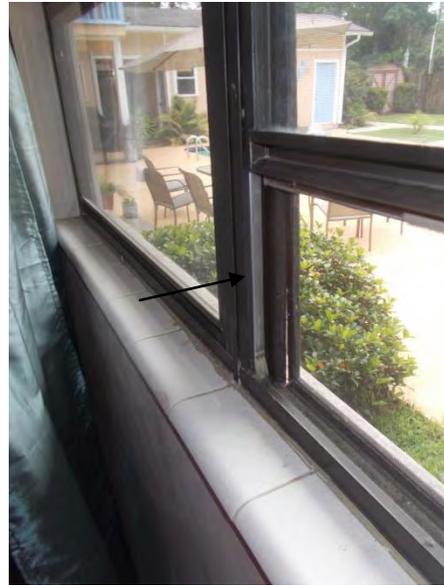
Windows and interior doors were operable. Two windows (bedroom and dining nook) have broken slide balances that should be replaced. One master bedroom window needs a lock latch.

Steel-braided hoses at washer - One of two broken window slide balances
